## Dee Alternative Mitigation

# Fisheries bulletin

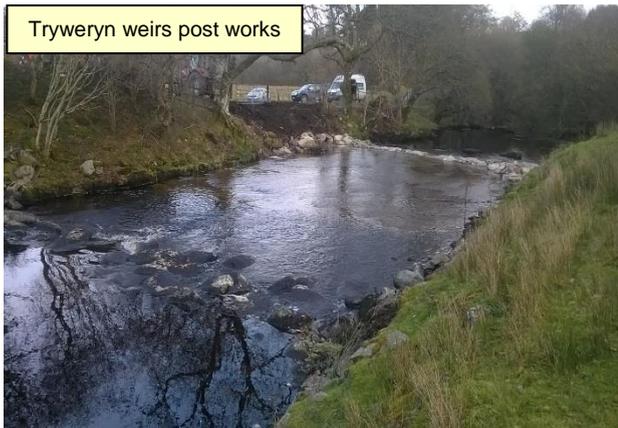
Tryweryn weirs post works

Additional spawning for salmon has been created in the Afon Tryweryn below Celyn Reservoir. This has been possible due to Alternative Dee mitigation funds which concentrates on improving access and habitat to spawning fish rather than stocking. A second low level weir has been constructed and in total over 400 tonnes of gravel have been placed at these structures.

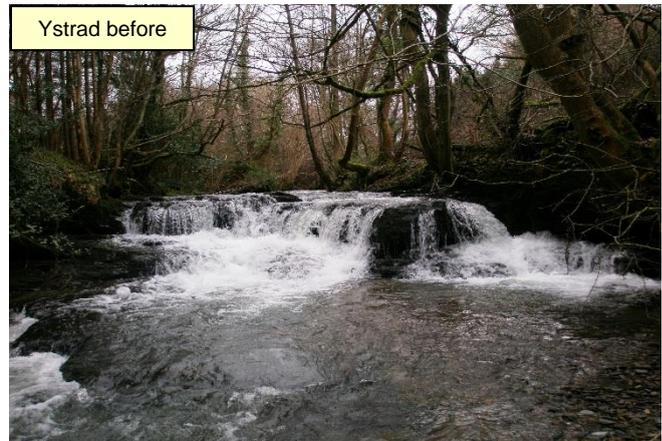
Ystrad before

This partial barrier to fish migration on the river Ystrad near Denbigh has been modified to allow easier access for upstream migrating fish as part of 'The Sustainable Fisheries Project'. Prior to the work, the 1.3-metre-high falls had water falling on to rock, which prevented fish from easily jumping the falls. Now migrating fish will be able to swim up the channel created and access the underutilised spawning/juvenile habitat upstream.

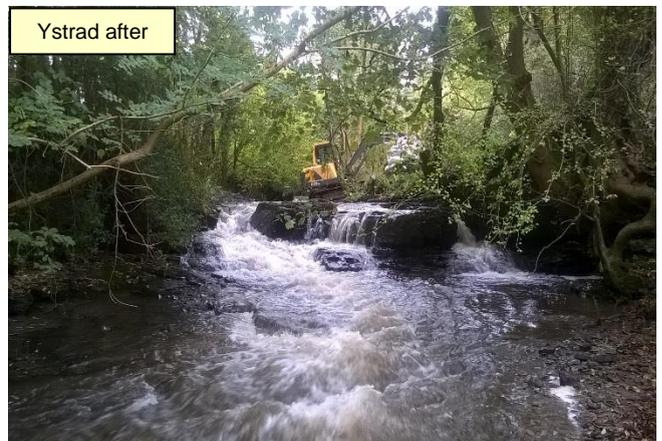
Ystrad after

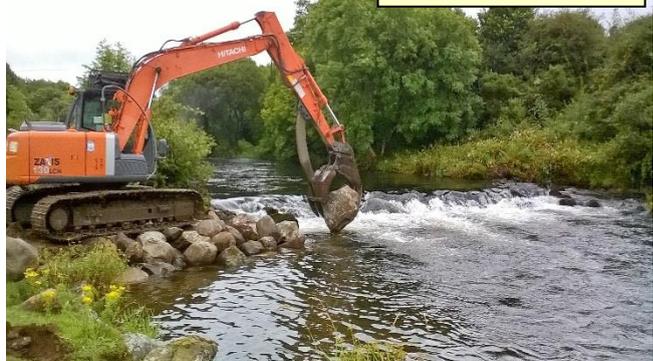
In river works at Crawia

As part of the Seiont alternative mitigation, NRW has improved fish passage at three boulder weirs and provided additional cover for fish, adjacent to Crawia Hatchery. In July of this year, working with members of the Seiont Gwyrfaï and Llyfni Fishing Society, we have installed boulders in areas where there is a lack of cover; maximising opportunities for fish to rest and seek shelter on their journey

upstream. There are several boulder weirs that delay fish passage upstream in this area, and part of the work involved the construction of two boulder pre-barrages and a small rock ramp. These three easements should reduce the delays and energy used by Seiont fish on their journey to their spawning grounds, improving their contribution to the fish populations in the river.

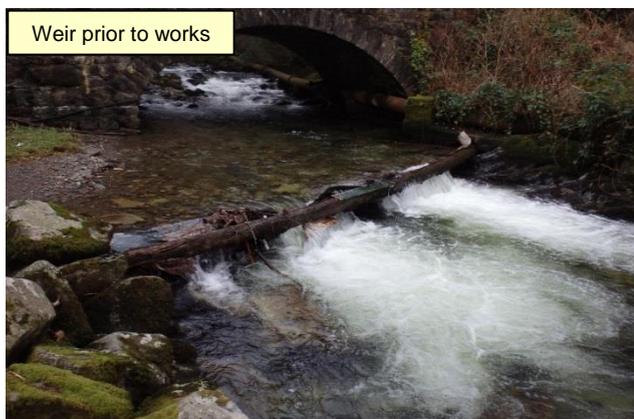
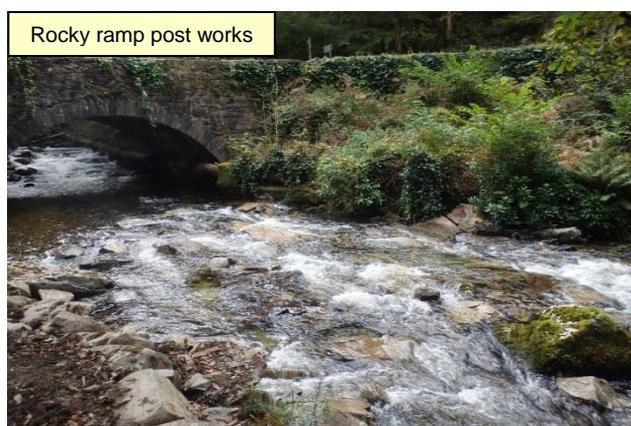
construction, took a week to complete the scheme without the use of concrete, and sourced boulders locally to blend the construction into the rivers environment.

Afon Gwynant, a tributary of the Mawddach catchment, was identified as having problems with salmon migration because of several manmade partial barriers constructed in the 1900's. Electro fishing surveys on this catchment highlighted the only location where salmon were present was below a disused weir. This obstruction impedes the passage of salmon and sea trout. A fishery funded scheme to profile the weir as a rocky ramp to ease the passage for salmon and sea trout was agreed by the landowner and fishery partners. NRW contractors, experienced in fish pass
